Department of Water Resources

PILOT LEVEE MAINTENANCE STUDY

Preview of Bulletin No. 167

FEBRUARY 1966

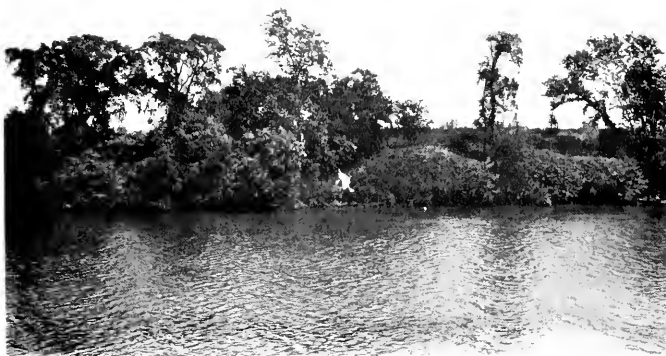
Undisturbed levee section demonstrating  
deferred maintenance. Inspection is  
practically impossible.

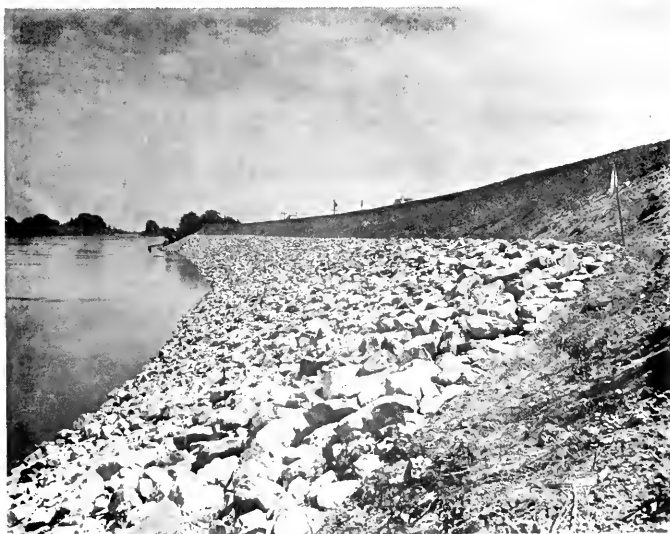
Reconstructed levee revetted with rock.  
Flood control consideration only.

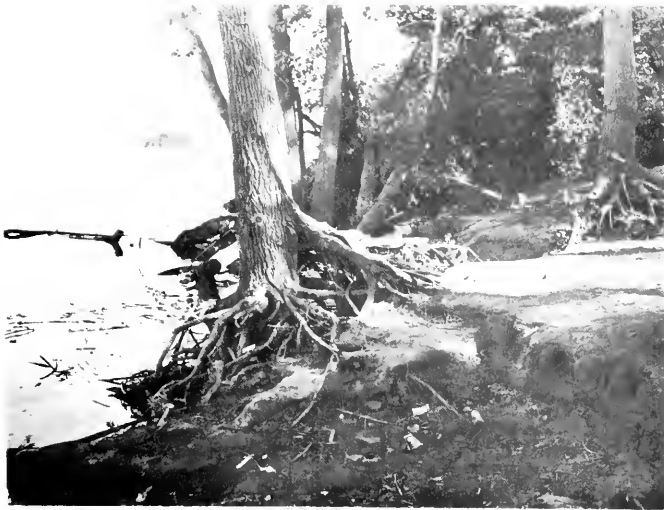
Typical example of erosion around trees  
endangering levee stability.
